Antimicrobial resistant – multidrug resistant – infection in tail with distal bone exposure

Staffordshire Bull Terrier Male 6 years old

Day 0” equals the first day of MPPT application

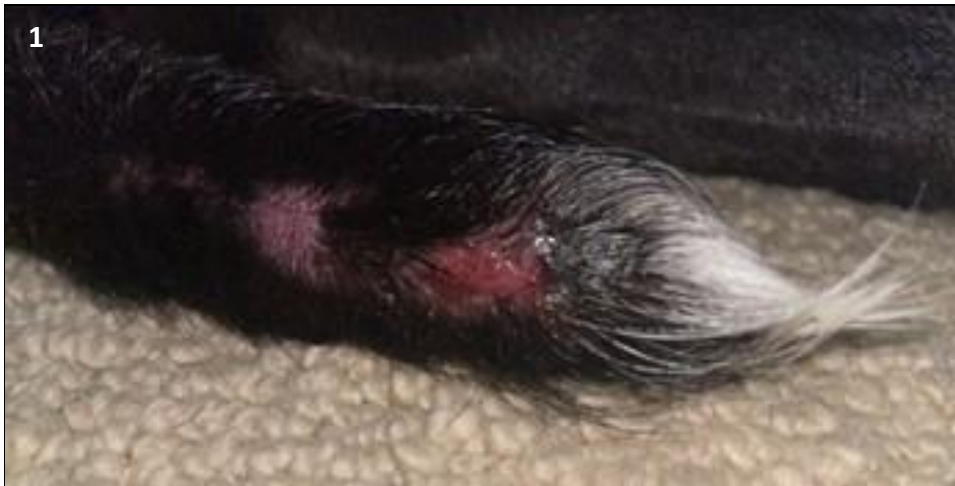
Day minus-19

12 days after the accident. Day 3 of a 5-day systemic Cephalexin antibiotic course. 1 day after starting daily chlorhexidine bathing and topical antibacterial-antifungal-corticosteroid-ointment.

Infection is spreading cranially. Hair loss and inflammation.

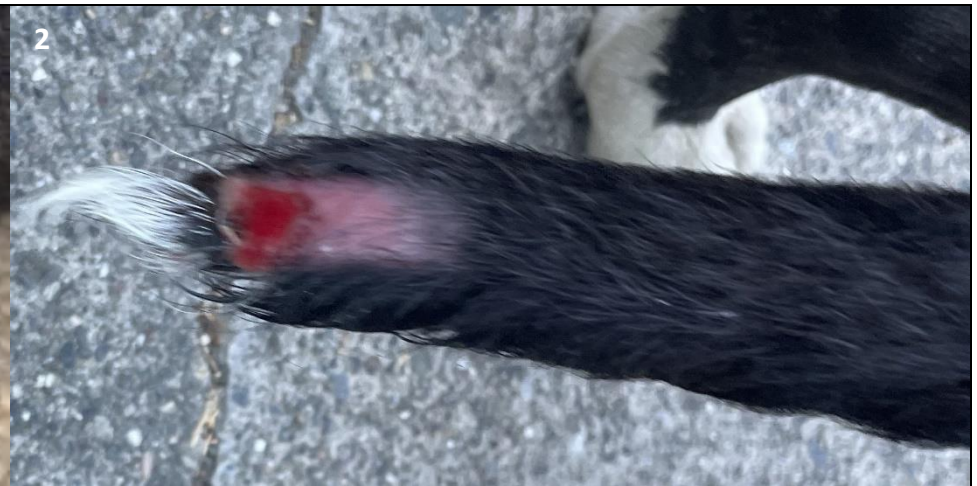
Day minus-12

After 8 days of Chlorhexidine bathing and topical antibacterial-antifungal-hormonal ointment.

Skin loos. Further hair loss. Dull appearance lacking vitality.

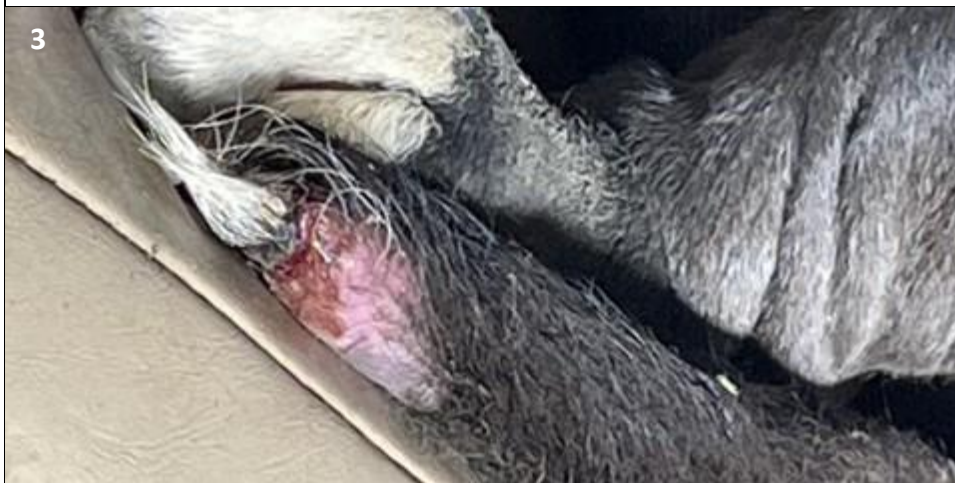
Day minus-6

After 24 hours with second course of Cephalexin antibiotics, combined with the daily Chlorhexidine soaking and antimicrobial ointment

The white-haired tip is infected, dry and necrotic. The dry necrosis is spreading up along the tail.

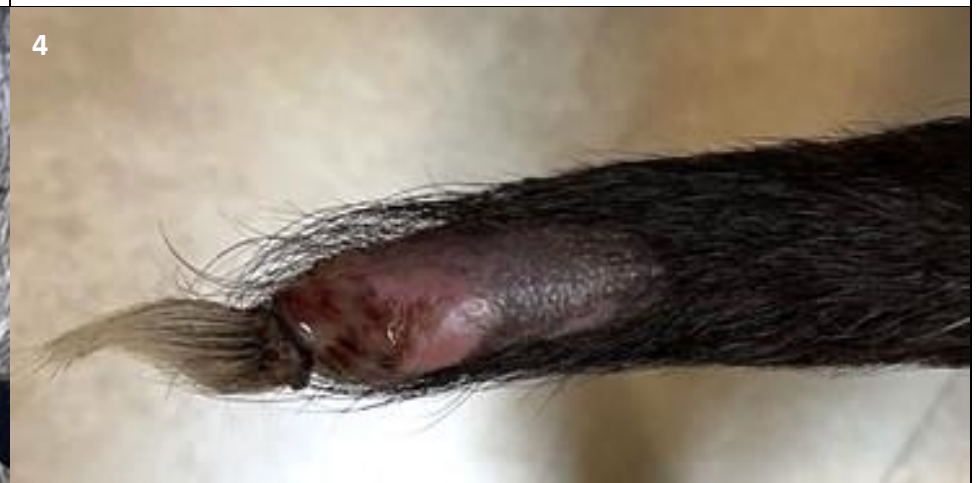
Day minus-4

After 72 hours with second Cephalexin antibiotics, combined with the daily Chlorhexidine soaking and the antimicrobial ointment

The infection has changed to wet necrosis. The infection is consuming the soft tissue and spreading cranially, e.g. evidence by further hair loss.

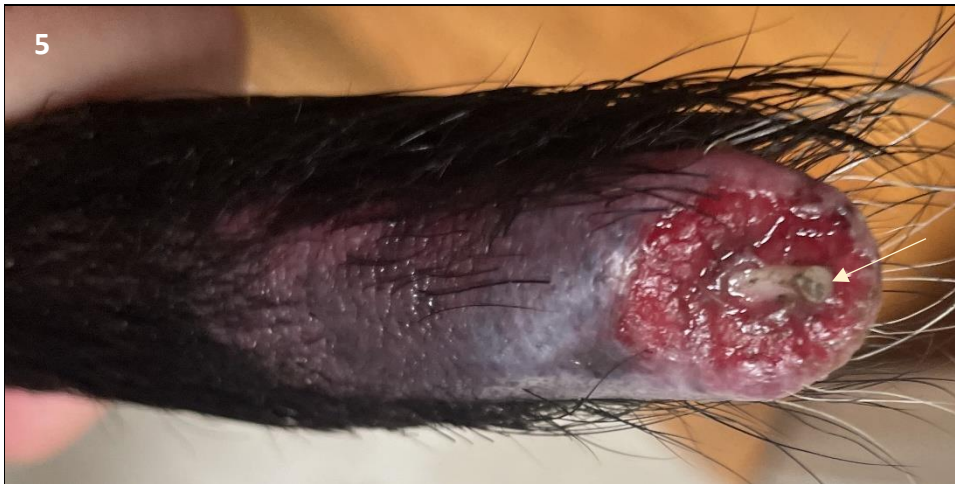
Day minus-2 - ventral
2 days before start MPPT

24 hours after the necrotic tip of the tail had fallen off by itself.

Approximately 5 mm of the tip of the bone are fully exposed and looking "dirty", but intact. Periosteum seems slightly affected but the bone is intact, and no sensitive structures inside the bone are therefore affected.

The tail is inflamed and swollen. The skin approximately 5 cm up the tail has lost its structure and is suffering hair loss involving the hair follicles.

The soft tissue is dark red and not granulating.

The wound edges are retreating.

Cream arrow: Bone extremity.

The dead tip fell off overnight leaving a 5mm tip of the tail bone fully exposed, but intact (pic 5). All medication was continued until MPPT treatment was started 3 days later. There is no photo from before the application on the day MPPT was initiated, but the one taken after 24 hours treatment shows an immediate reversal of the infection (pic 6).

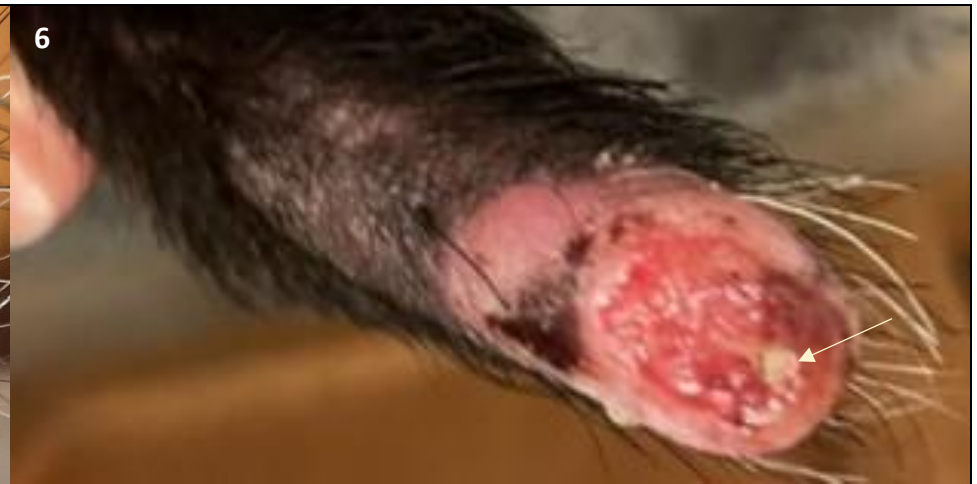
Day 1 - ventral
After 24 hours with MPPT

After 24 hours with MPPT.

The swelling and inflammation are reducing. The affected skin is regaining its structure. The most affected part of the skin (distal-most) is epithelializing. Pink granulation tissue is rebuilding the soft tissue around the bone, i.e. the part sticking out it considerably shorter.

The wound edges are actively epithelializing.

Cream arrow: Bone extremity.

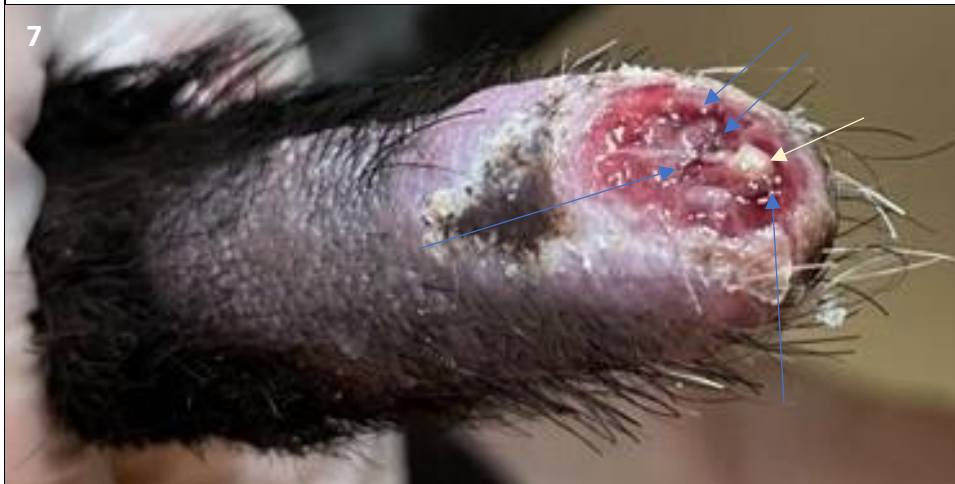
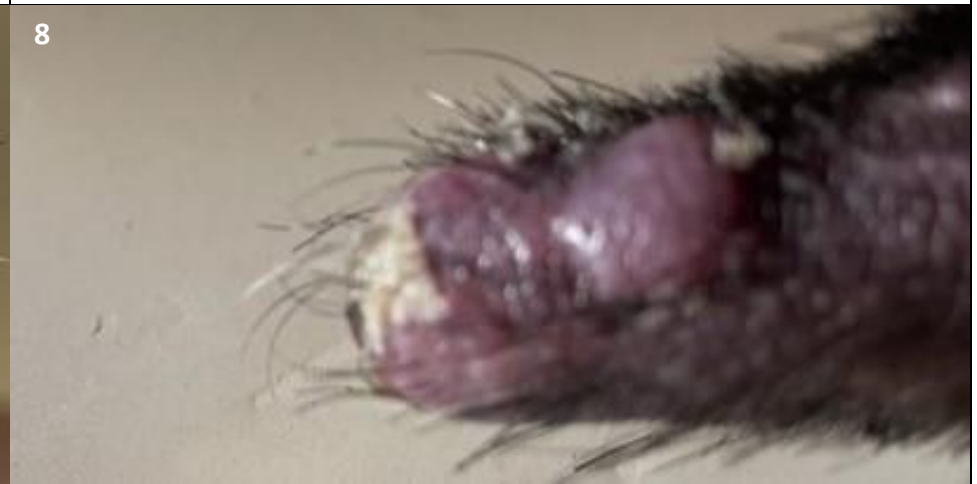
Day 2 - ventral

Skin structure and hair follicles are recovering.

The wound is regenerating missing tissue and the size of the open wound is reducing.

Blue arrows: clusters or “vesicles” of toxins collected in the deeper tissue layers and transported to the surface of the wound waiting for the final push onto the granulating wound surface from where it can be removed.

Cream arrow: Bone extremity.

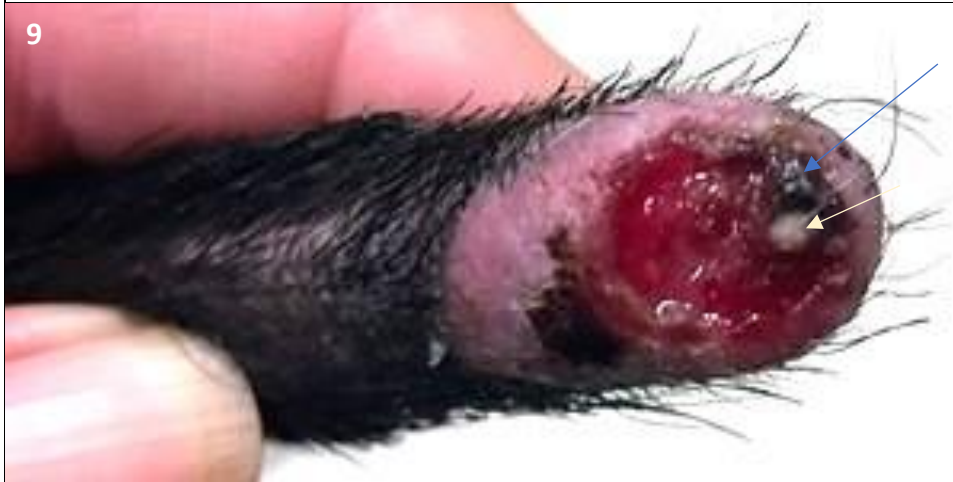
Day 2 - dorsal

The dorsal side has caught attention because it is showing a salient nodule a couple of cm further cranially from the tip than where the infection had been identified on the skin, i.e. from the outside. Such a nodule is a sign of an ongoing fight against a severe infection. It implies that the infection has been spreading relatively undetected inside the soft tissue.

Up until the start of MPPT, the focus had exclusively been on the ventral side with the exposed bone. However, the dorsal side soon revealed signs of also being involved in combatting the internal infection which had reached further cranially than exterior signs had previously implied (pic 8). This was dealt with (pic 13) and by the end of the second week the dorsal side was smooth filling in with new hair growth all over.

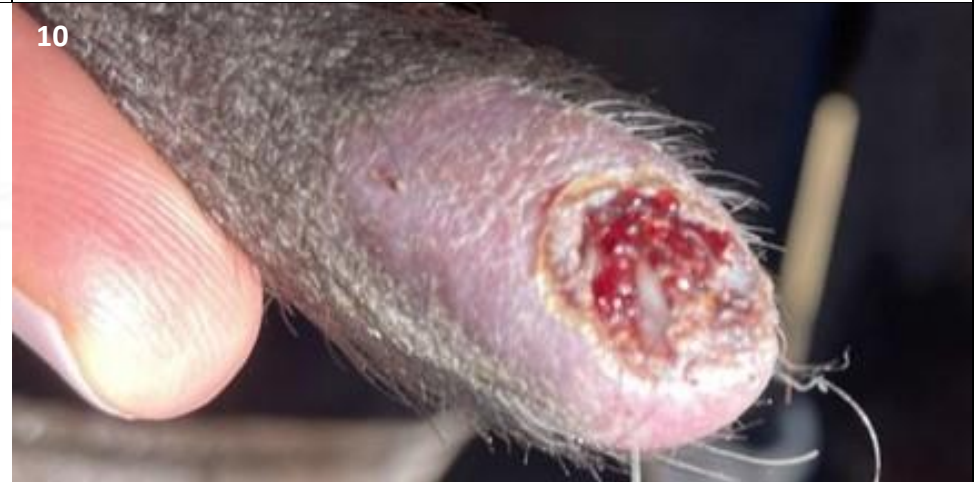
Day 4 - ventral

No more swelling. Hair is growing back on the intact skin that had lost the hair. The novel epithelium is maturing and gaining strength. Only the very tip of the bone is still visible. The rest is covered in new granulation tissue which again is being covered with epithelium. The thin blown film along the wound edges is protecting the epithelialisation taking place underneath it. It moves forward and leaves new epithelium in its wake ready to mature under the exposure to air.

Blue arrow: Mixture of an epithelializing brown film and a dried cluster of expelled toxins

Cream arrow: Bone extremity.

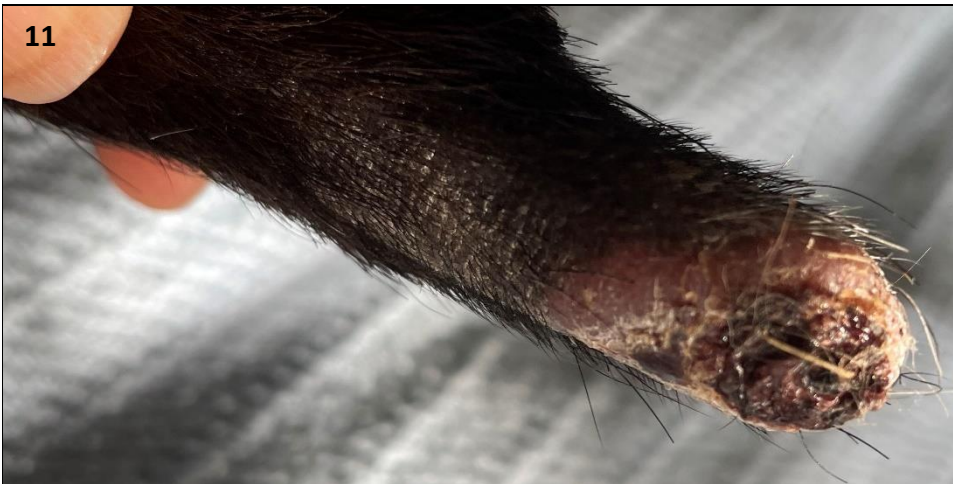
Day 5 - ventral - late in the day just before wash

Dried out toxins and other debris that has been expelled from the infected tissue onto the wound surface and has dried out forming a cap over the wound bed. This could be regarded as an “unhealthy” scab consisting of, e.g. toxins, dead tissue cells, dead immune cells and other debris. It is regarded as “unhealthy” because it covers a wound that still harbours infection and it therefore needs to be removed to make way for more debris yet to be expelled during the infection removal process.

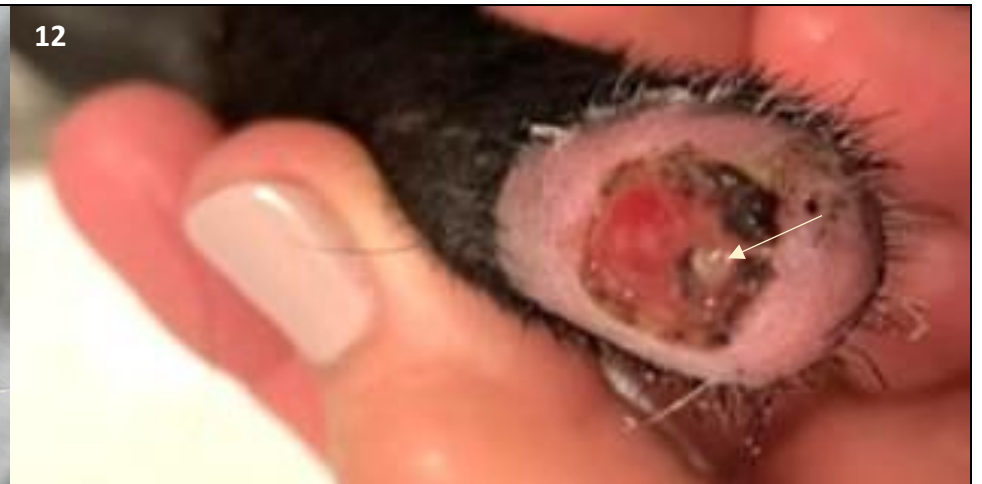
Day 5 - ventral - after wash

Scab along all edges. The epithelialisation occurs protected by this brown relatively soft film. In this case it also holds dried toxins and other types of debris. Despite this, it should not be physically removed if it does not fall off during the very thorough showering. It is important not to harm the thin brown film along the edges. At the next shower, the retained debris will have loosened enough to come off without using additional force. However, by then, new more recently pushed out debris may be stuck to the wound surface looking similar to the present situation.

Pink granulation in the wound bed. Bone still visible.

Cream arrow: Bone extremity.

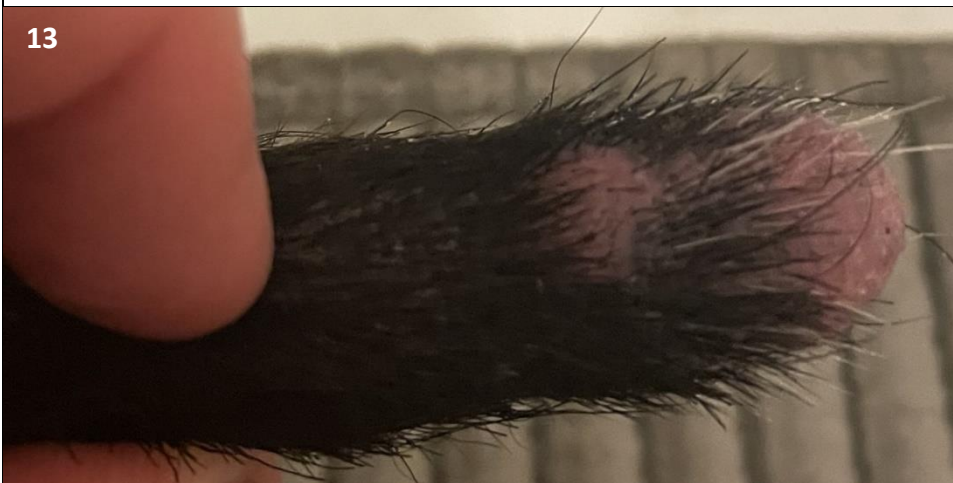
Day 8 - dorsal

Please compare to pic 8. The nodule revealing dorsally the presence of the internal infection is rapidly reducing, the intact but affected skin is recovering and new hair is moving in.

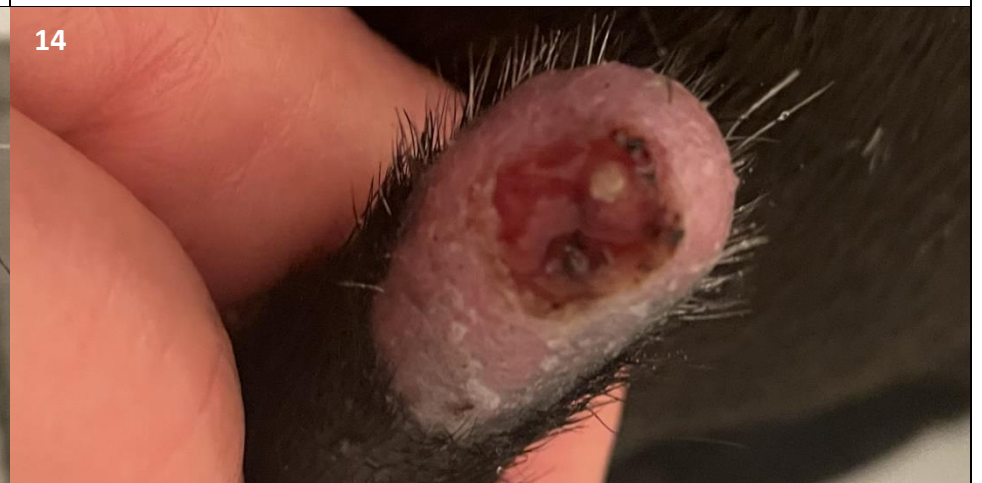
Day 8 - ventral

The size of the wound is reducing. The wound bed is granulating and filling in missing tissue leaving the pearly bone extremity only just visible. The wound edges are epithelializing, whilst the new skin (pink) is maturing and the damaged but intact skin is recovering (greyish).

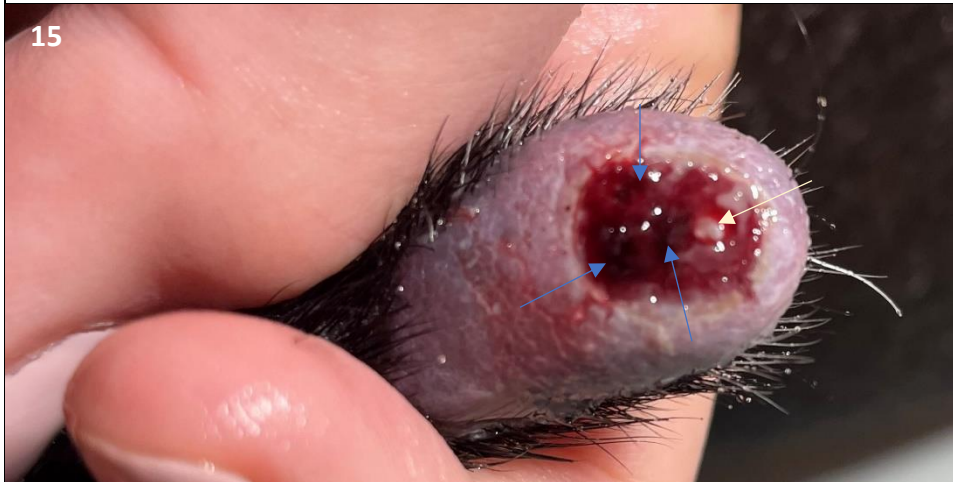
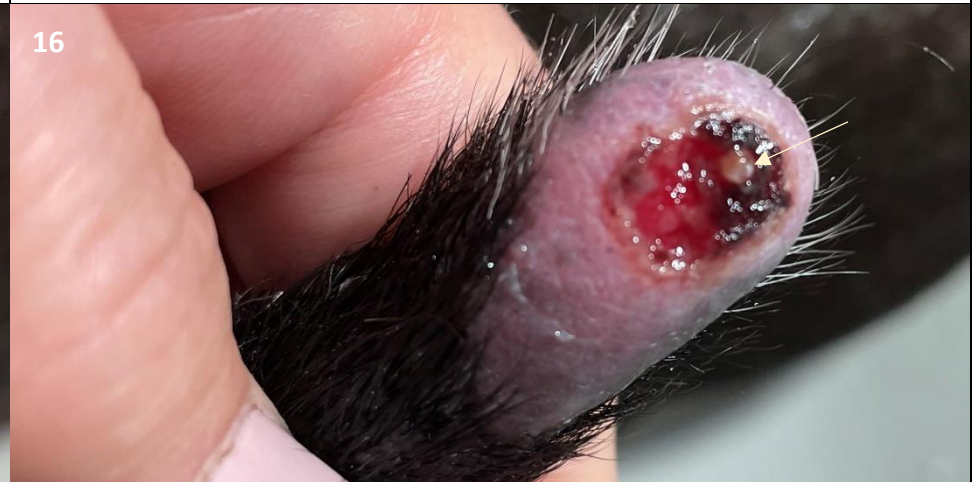
Day 10 - ventral - after wash

red pigmented toxins looking similar to blood coming out during washing

The washing of the tail coincided in time with the definitive expulsion of red bacterial toxins from soft tissue vesicles. The toxins are moved to the wound surface in vesicle-like structures. Once there, the vesicles burst, releasing the toxins outside of the soft tissue. The toxins were removed by the water looking similar to a bleeding. The release of toxins had not finished by the end of the shower, and the picture is taken directly after washing and enables the recognition of dark nodes just under the surface between the granulation tissue. The situation is similar to picture 7, but in the present picture the expulsion is actively ongoing (the vesicles have burst) whilst in pic 7 the toxins are still contained inside vesicles, probably still waiting for the final push to reach the surface and ensure their content is spilled outside the soft tissue, once they burst.

Blue arrow: Red pigmented vesicles containing the red pigmented toxins from the abscesses scattered in the soft tissue after being transported by the immune system and readied for expulsion onto the granulating wound surface.

Cream arrow: Bone extremity.

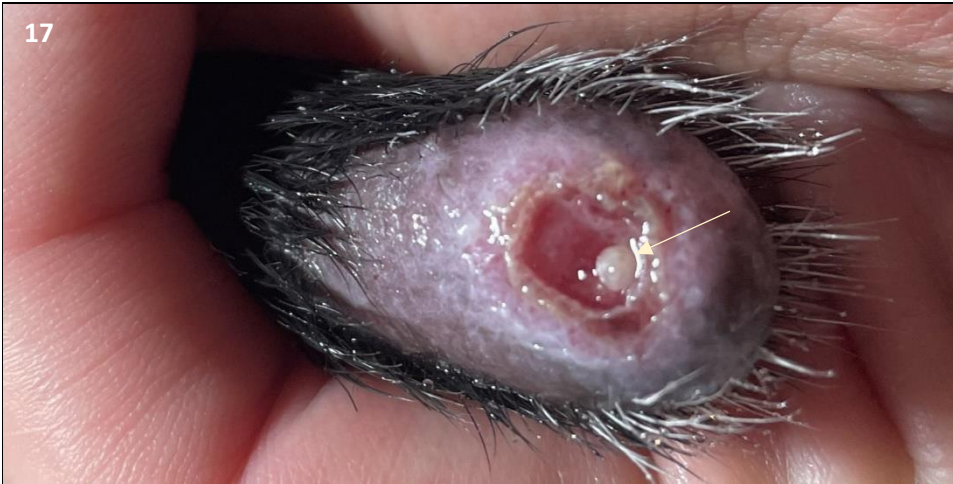
Day 15 - ventral

Healthy granulation and strong epithelialisation under the brownish film along the entire edge. Skin pigmentation is being restored. Pearly looking bone extremity in the final stages of repair of its periosteum.

Cream arrow: Bone extremity.

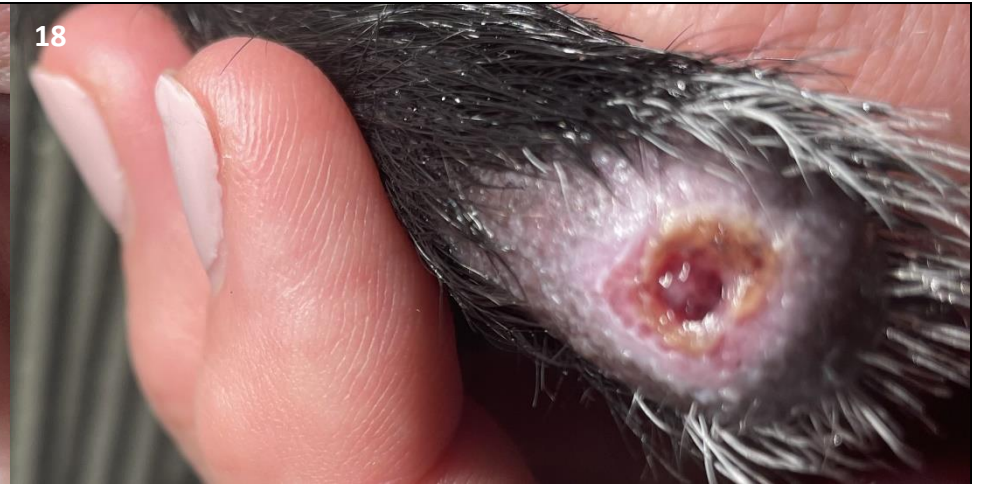
Day 19 - ventral

The wound is now free from infection and reduced to the size of the circumference of the extremity of the bone. The bone is covered with granulation tissue and readying for epithelialisation. Hair growth is being restored.

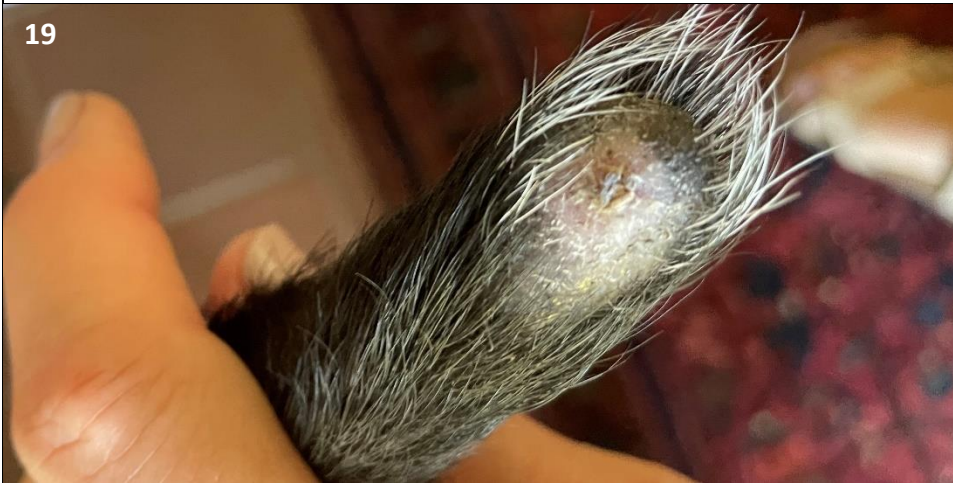
Day 28 - ventral

Closed

Wound has been closed for 24 hours and the dog is taken to the beach for a swim.

The processes of infection removal and tissue recovery continued steadily (pic 17). Once the soft tissue surrounding the bone was sufficiently free of infection and the tip of the bone, that was sticking out, had been cleaned and any damage to the periosteum had been repaired, the bone was protected with granulation tissue and subsequently with epithelium (pic 18). Because the dog had had so copious systemic and topical antimicrobial treatment during the first month following the accident, the infection was deemed tenacious and MPPT treatment was continued until closure. The dog lived in a hot climate and the day following closure he was off to the beach and a longed-for swim (pic 19). This did not impact healing (pic 20).

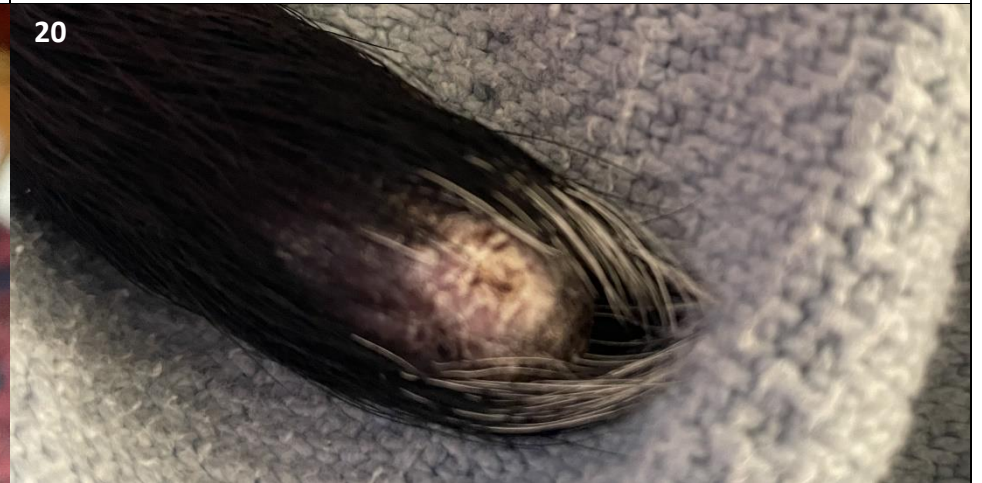
Day 36 - ventral

The scar is 3 x ¼ mm. A 5x5 mm area of new skin around the scar is still undergoing the last phases of maturation. Such remodelling will typically continue to add strength and resilience to the tissue for months or even years.

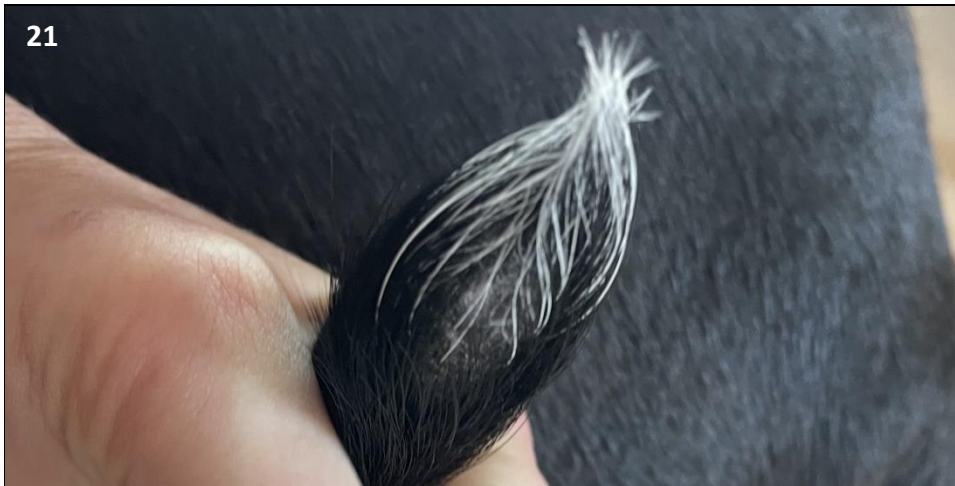
**Day 65 - ventral
Follow-up**

White hair on tail tip is back. Pigmentation has been re-established.

The infected skin along the tail healed completely restoring all his original pigmentation and hair growth. The owner had always been very fond of his white-haired tail tip against his otherwise intense black fur and was delighted to see the regrowth of his hallmark white tip (pic 21, 22). Follow-up 2½ months after full closure showed a dog that had fully moved on after the accident and was not bothered by his tail at all (pic 23, 24).

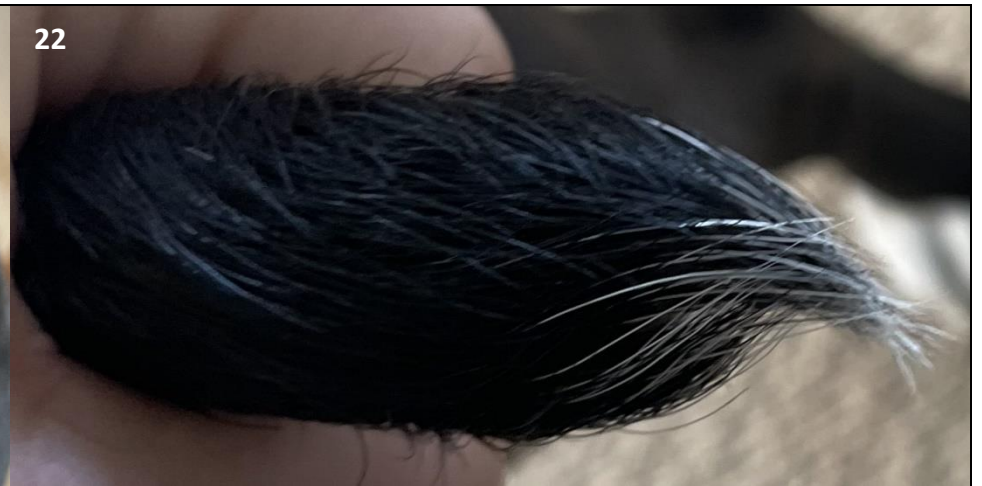
23

**Day 65 - dorsal
Follow-up**

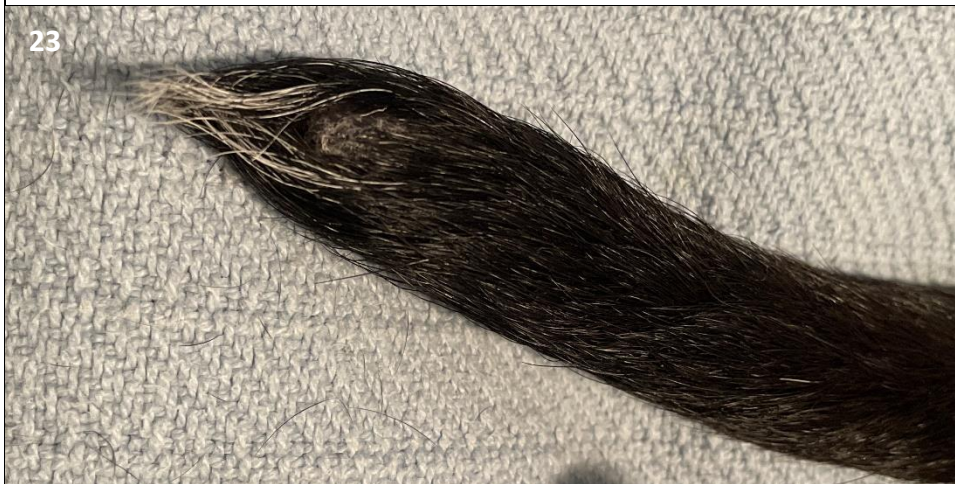
**Day 109 - ventral
Follow-up 2½ months after closure**

Fully stable closure. No concerns. Dog shows no interest in his tail and leads a life identical to before the accident.

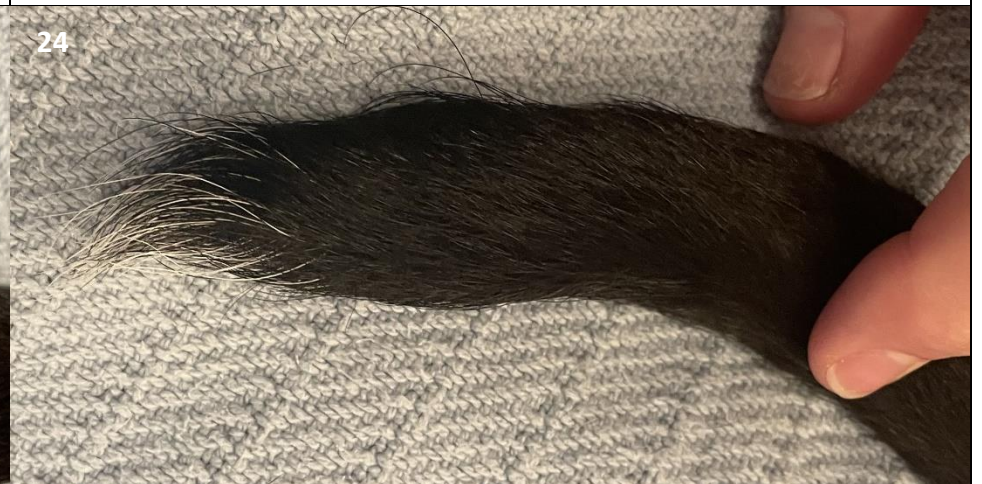
24

**Day 108 - dorsal
Follow-up 2½ months after closure**
