Necrotising fasciitis, AMR, in proximal end of dog's tail

English Mastiff Male 3 years old

Day 0 equals the first day of MPPT application

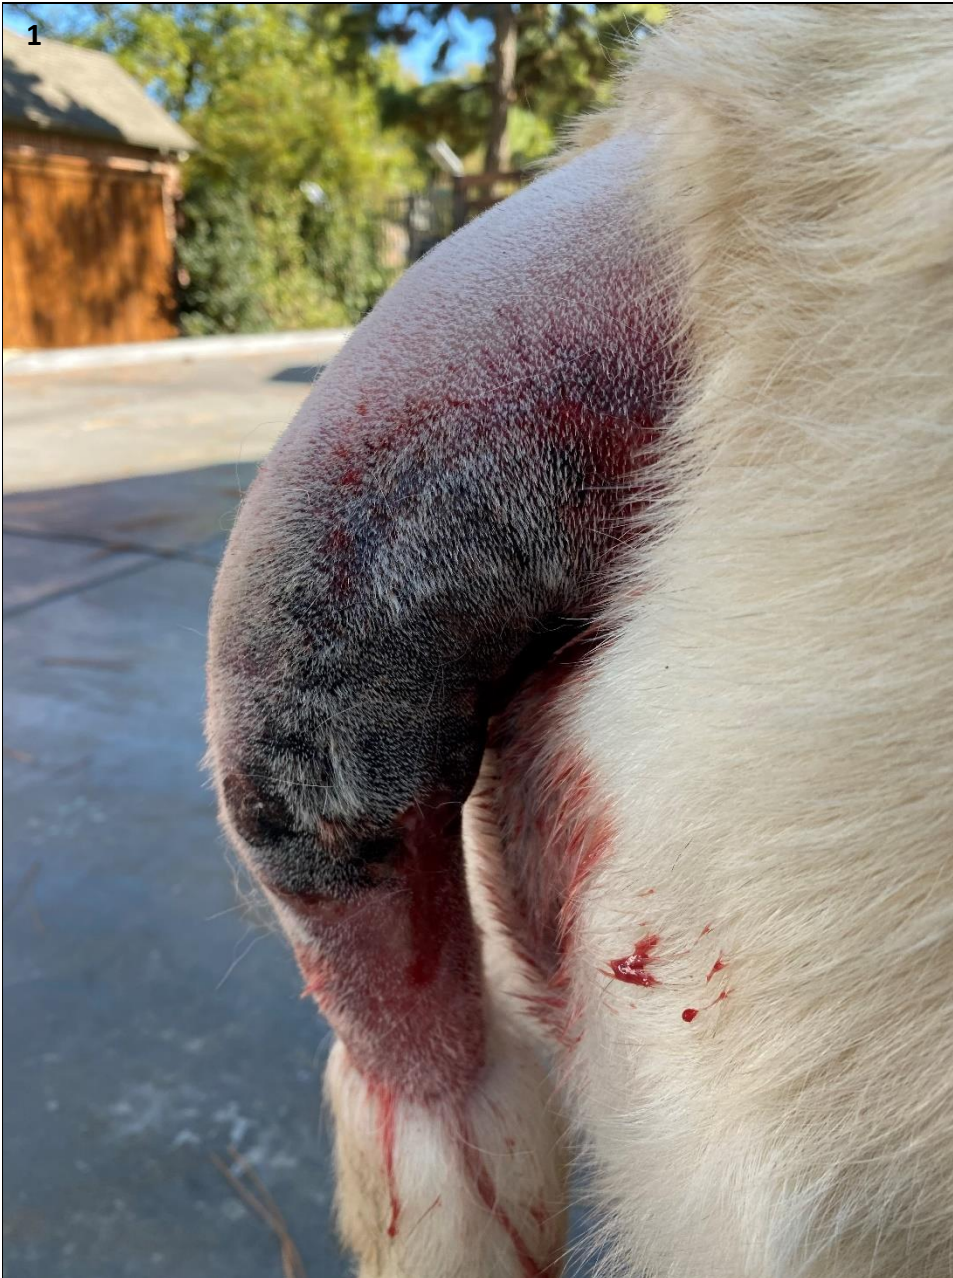
Day minus-9

A black spot on the tail had been detected 5 days earlier by the owner. Over the 5 days period it had developed into this rapidly spreading necrotizing fasciitis.

Here, it had been cleaned and drained by the vet.

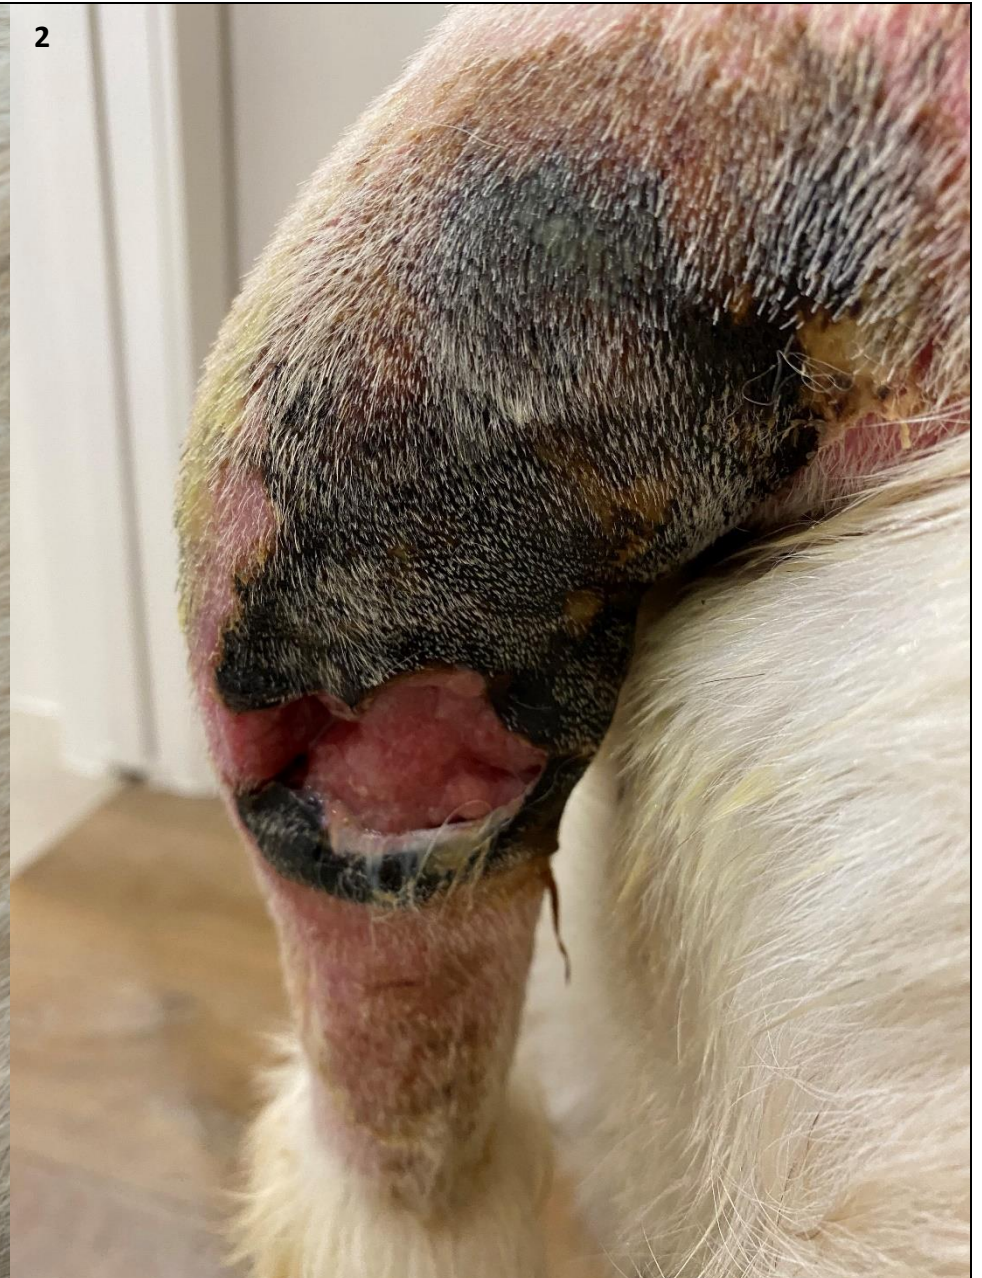
Day minus-2

Cleaned and drained by the vet.

It is necrotizing quite deep into the flesh. Most of the loose, dead skin has been removed.

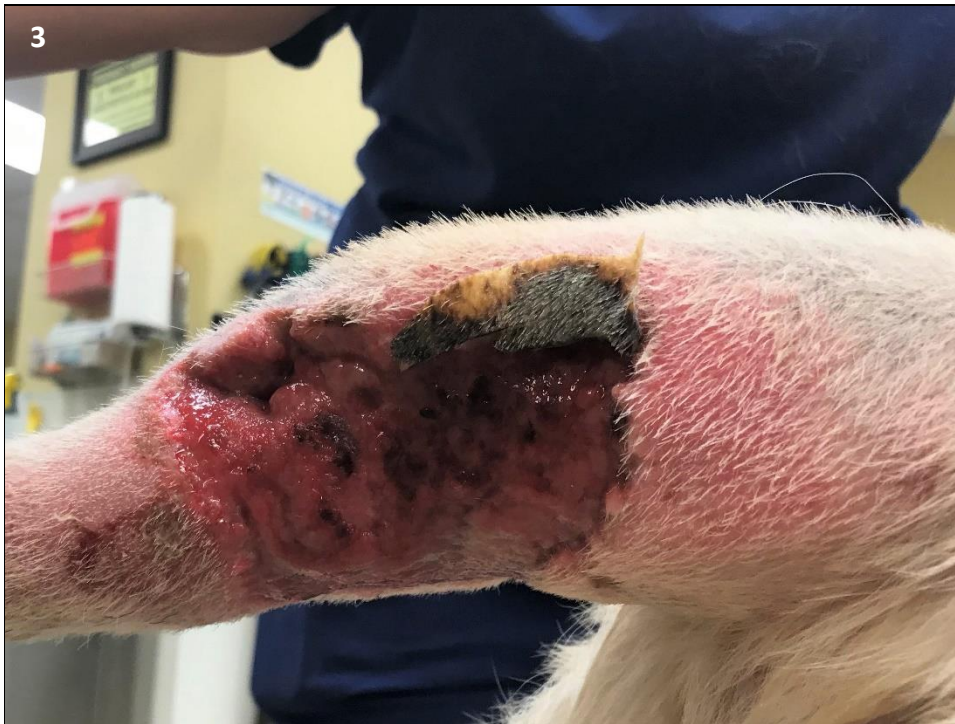
Day 0

The infection in the flesh underneath the loose, removed, dead skin has dug deep and continues tunnelling in several places showing the soft tissue covered with disseminated black necrotic areas of varying sizes. The tunnel in the distal dorsel corner is particularly prominent. The intact skin along the wound edges is erythematous quite far in all directions with the necrotizing process particularly advanced ventro-laterally in the distal direction even though the skin has not yet detached.

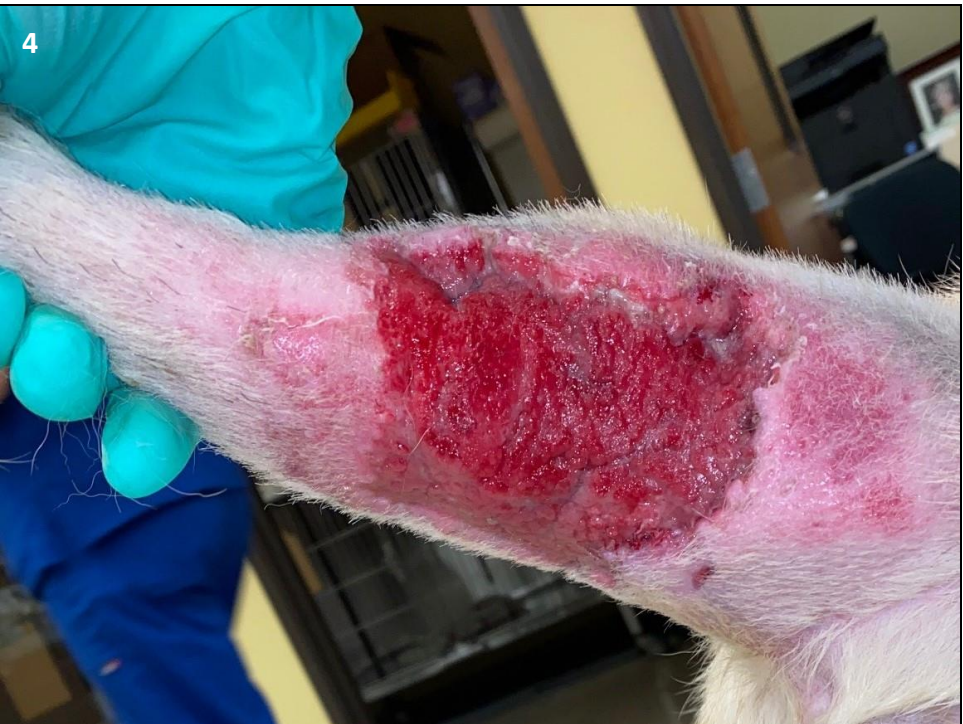
Day 1

The spread of the infection has stopped.

The wound bed is red and granulating. The dark necrotic areas have practically disappeared. The shedding of the last attached black necrotic piece of skin in the dorsal proximal corner has revealed an easily recognisable tunnel underneath. This, however, is already granulating and the likewise exposed skin edge is also regenerating. The wound edges are pink and healthily epithelializing. The progressing inflammation of the skin in all directions has been stopped and displays a clear border. The most affected areas of what seemed intact skin are granulating and epithelializing at the same time. The dead skin/eschar has come off and is exposing healthy soft tissue and a healing skin edge underneath.

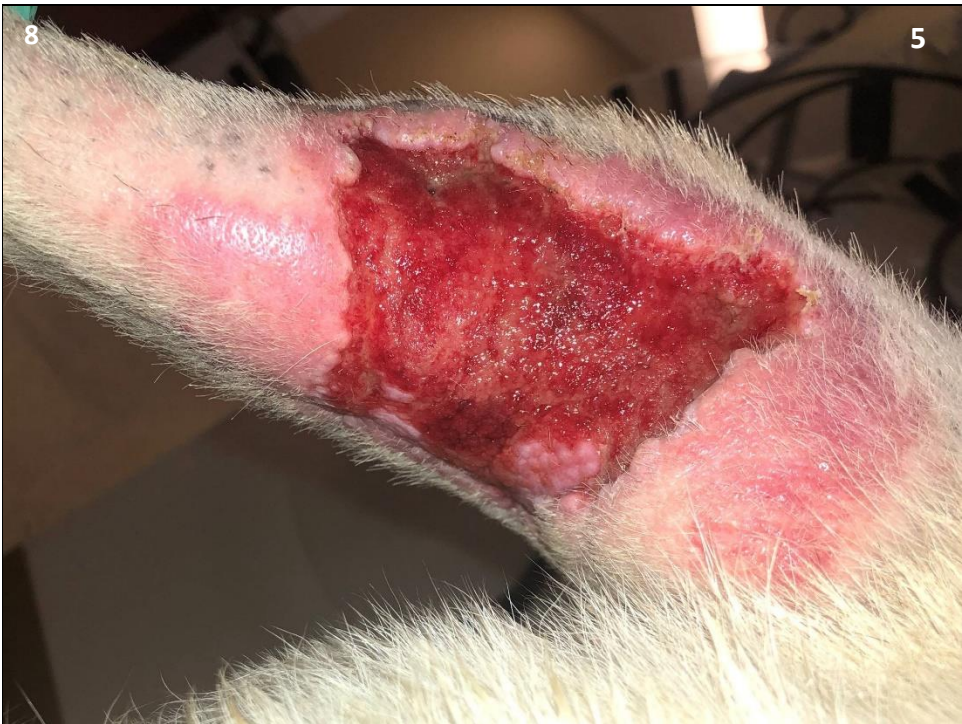
Day 4

After last daily treatment with MPPT.

The infection has been removed. The entire wound bed is granulating. All wound edges are epithelializing. Islands of epithelium are present along the ventral edge of the wound, particularly the cranial, ventral corner. The affected, intact skin is undergoing repair.

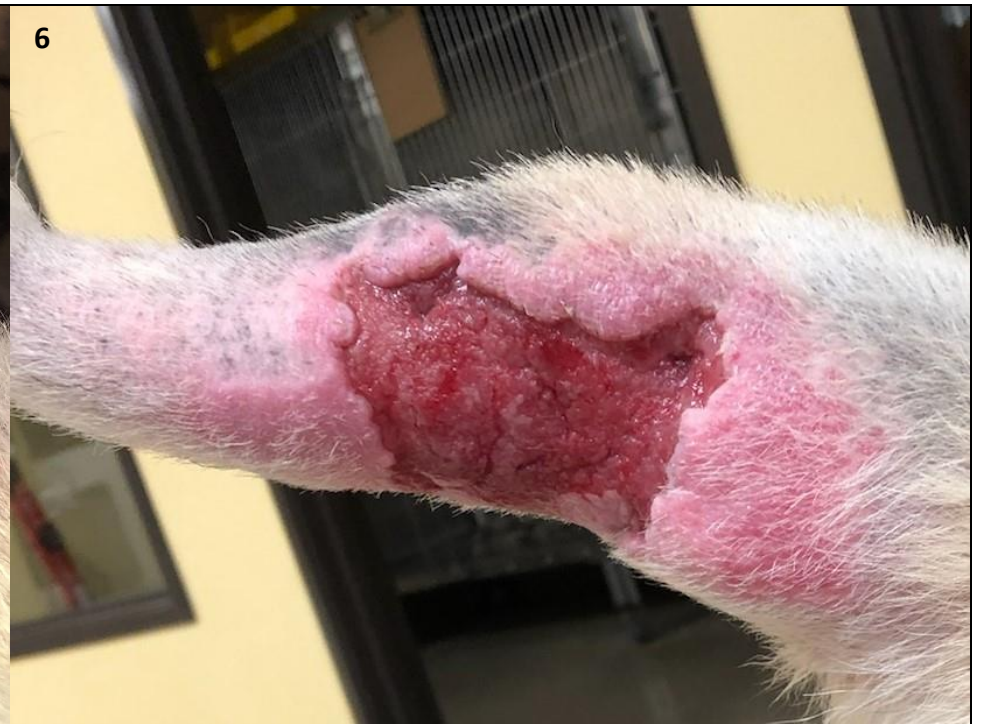
Day 5

After 24 hours without MPPT and shortly after the daily thorough showering with tap water.

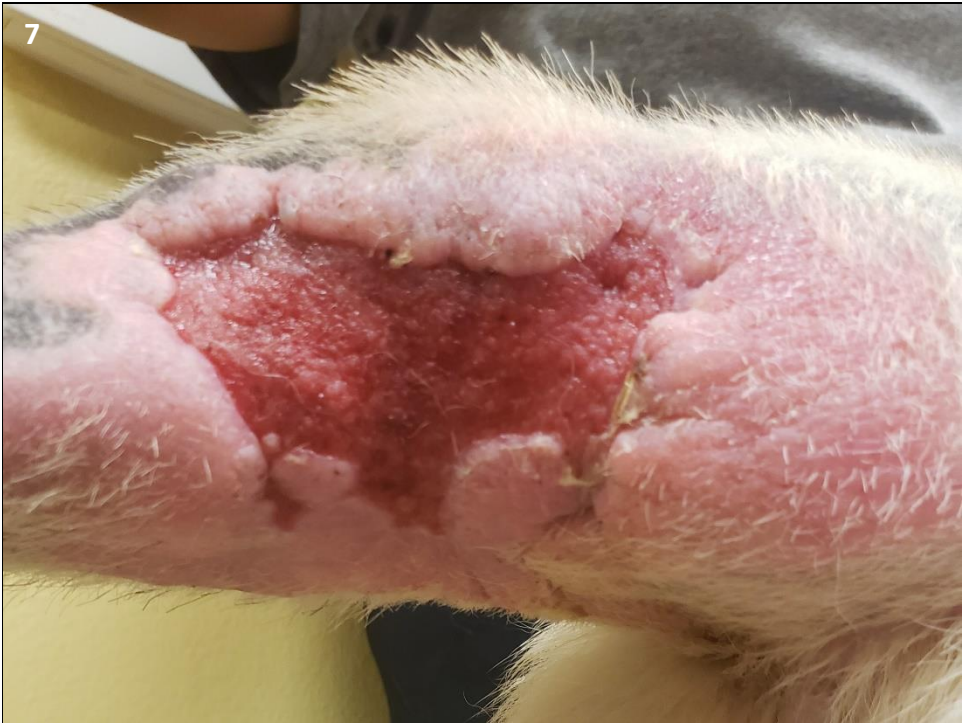
Day 10

The wound is rapidly reducing in size. The tunnel in the distal ventral corner has fully filled in with granulation tissue and is no longer present.

The wound and surroundings remain free of infection.

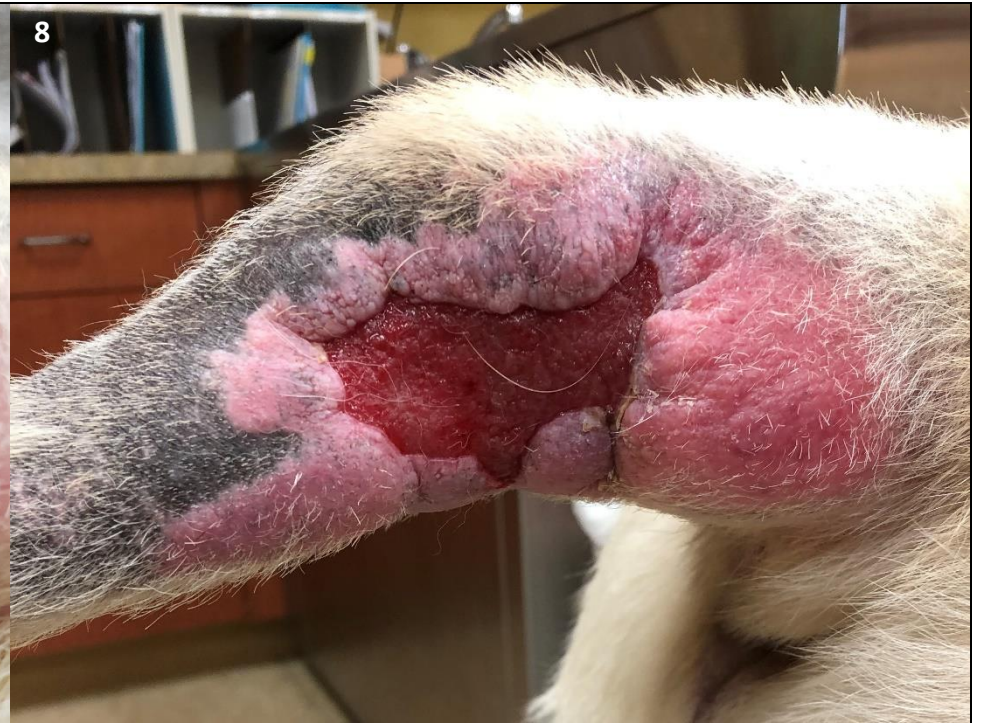
Day 14

Continued reduction in size with epithelialization along all wound edges. The epithelial islands are joining with the epithelium at the edges.

The new skin is displaying new hair follicles as well as pigmenting well.

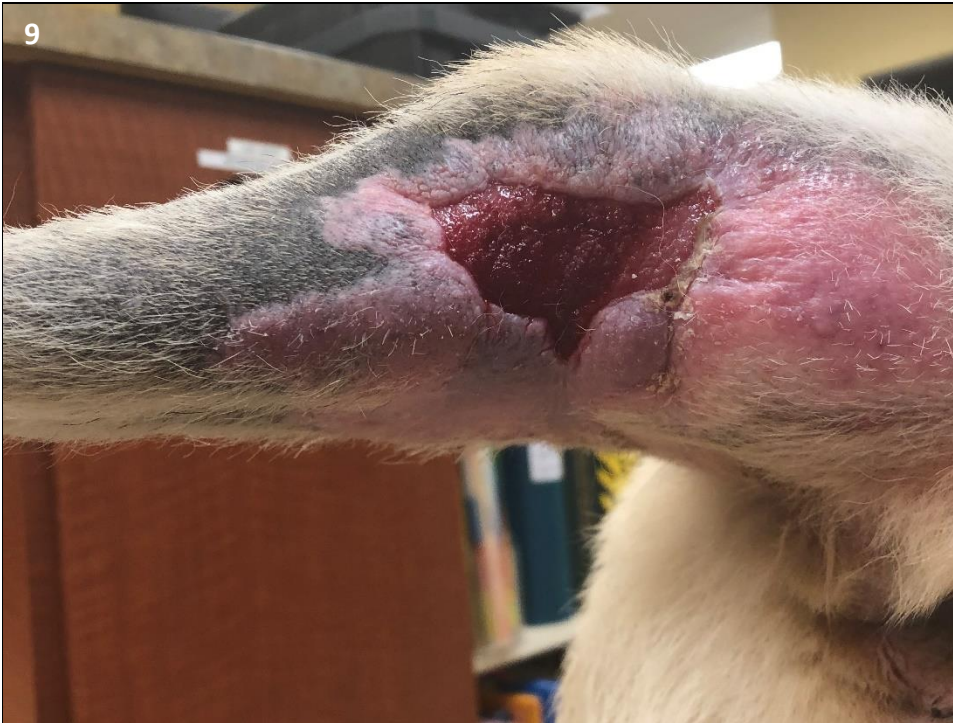
Day 17

Continued reduction in size from epithelialization along all wound edges. The new skin is displaying new hair follicles as well as pigmenting well. Still no sign of infection anywhere. The cranial edge is displaying healthy scab.

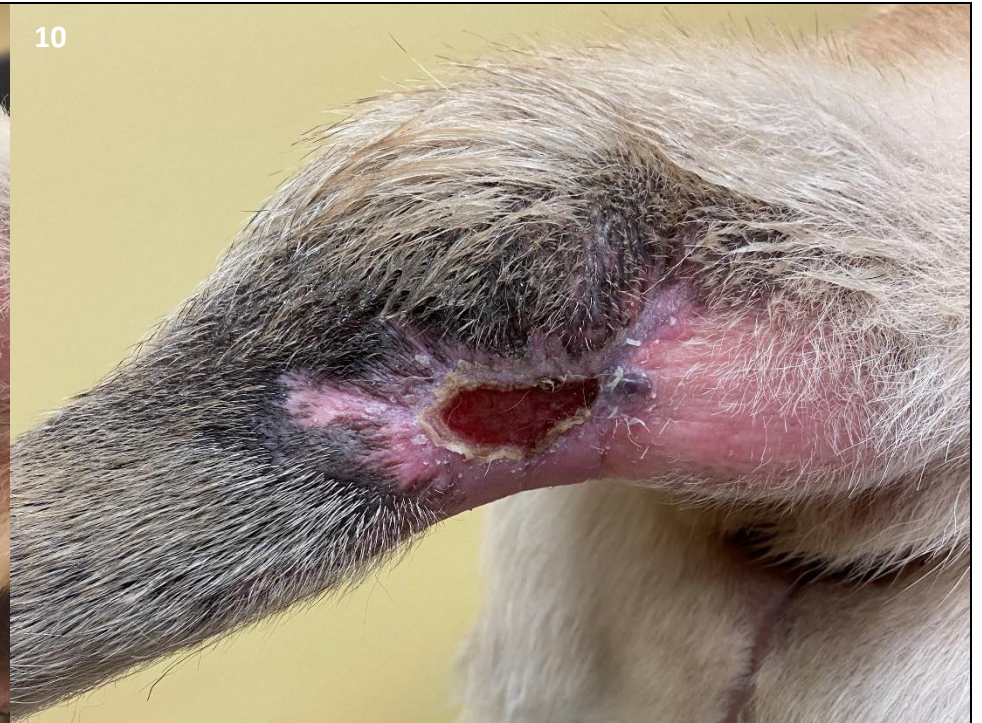
Day 29

All skin has fully recovered. All new skin is pigmented and displaying hair growth.

The scab along the wound edges is correctly left intact.

The wound and surroundings remain free of infection.

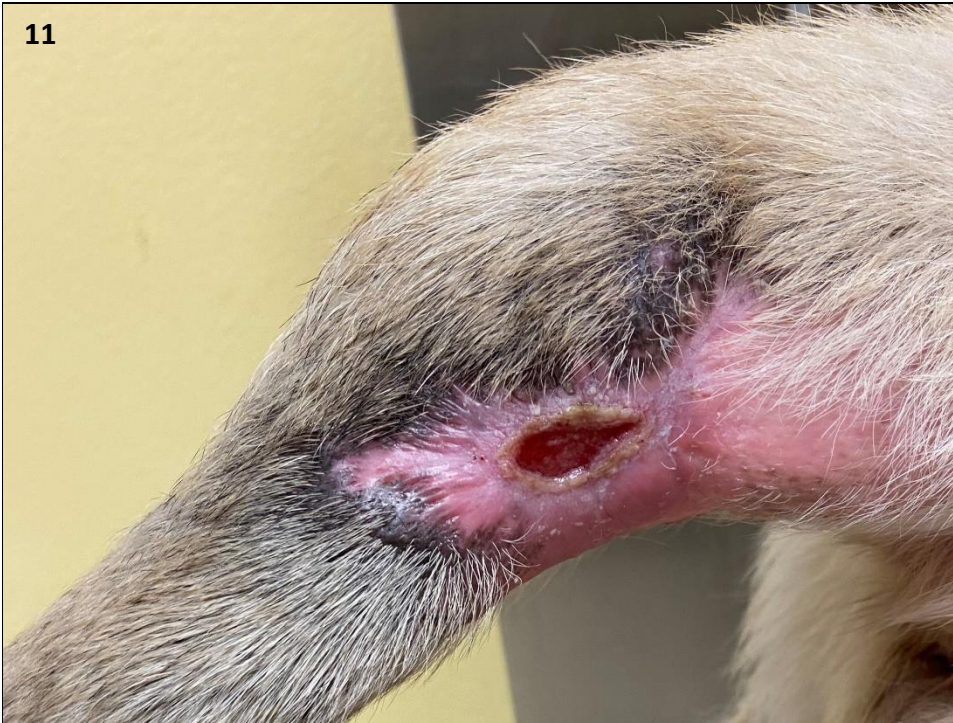
Day 36

MPPT had been applied 24 hours prior, exclusively as a precaution. No clinical signs were demanding this additional treatment.

The healing was boosted with strong epithelization and healthy scab formation along all edges.

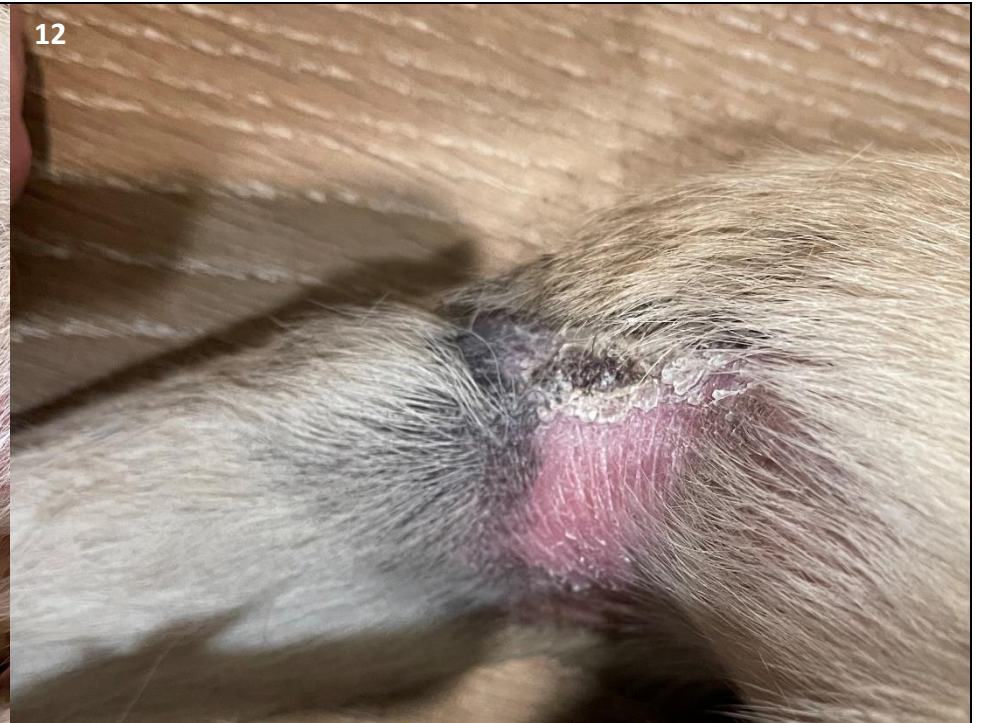
Day 49

A small scab remains in the dorsocaudal corner. The rest is healed. The majority of the new skin is fully functional; only a quite limited area has regenerated as scar tissue.

The wound is no longer washed daily.

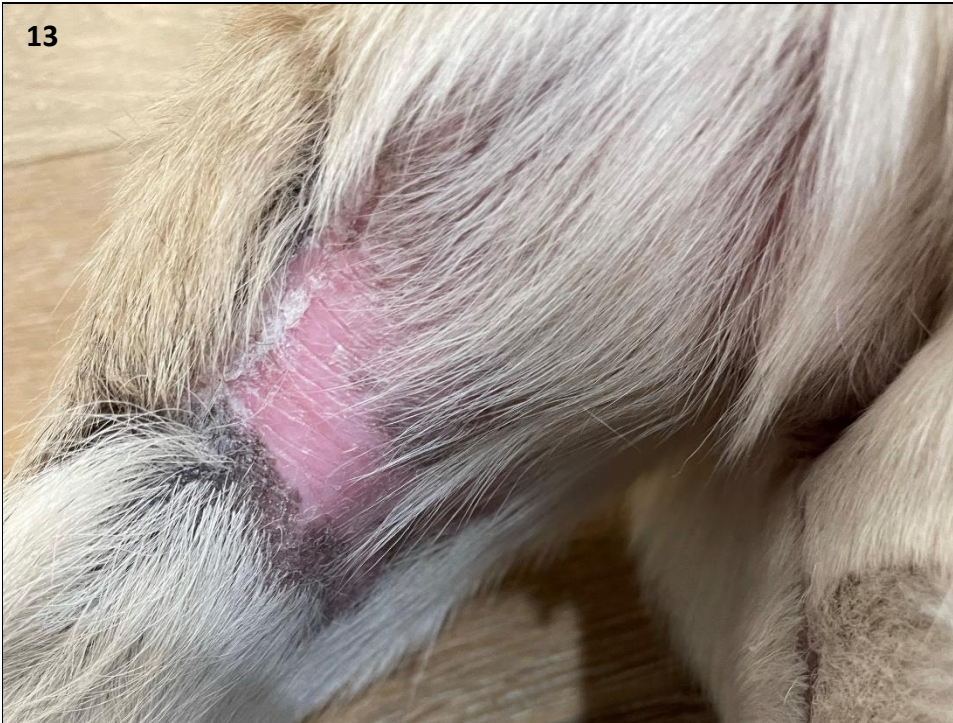
Day 63
Full closure

The last bit of scab falls off by itself revealing healthy skin and a fully closed wound.

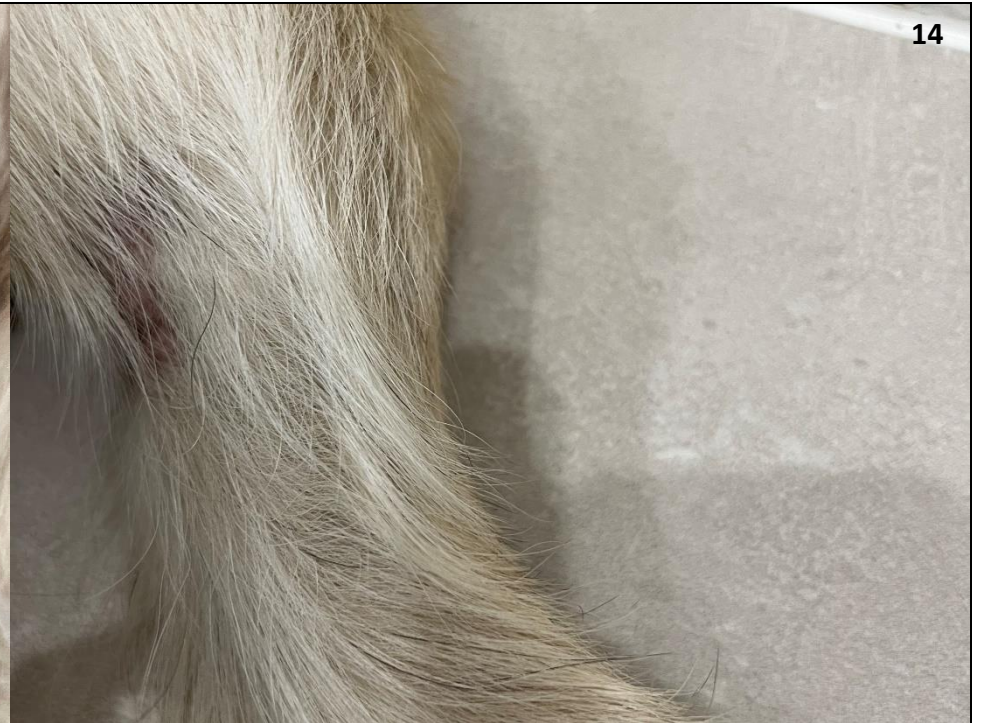
Day 558
1½ years later – follow-up

Except for a limited area of scar tissue, the skin restored pigment and hair growth. There have been no signs of unease in the area or other issues with the tail following closure.
